Pollution Identification and Correction

A Public Health Approach to Low Dissolved Oxygen in
Hood Canal

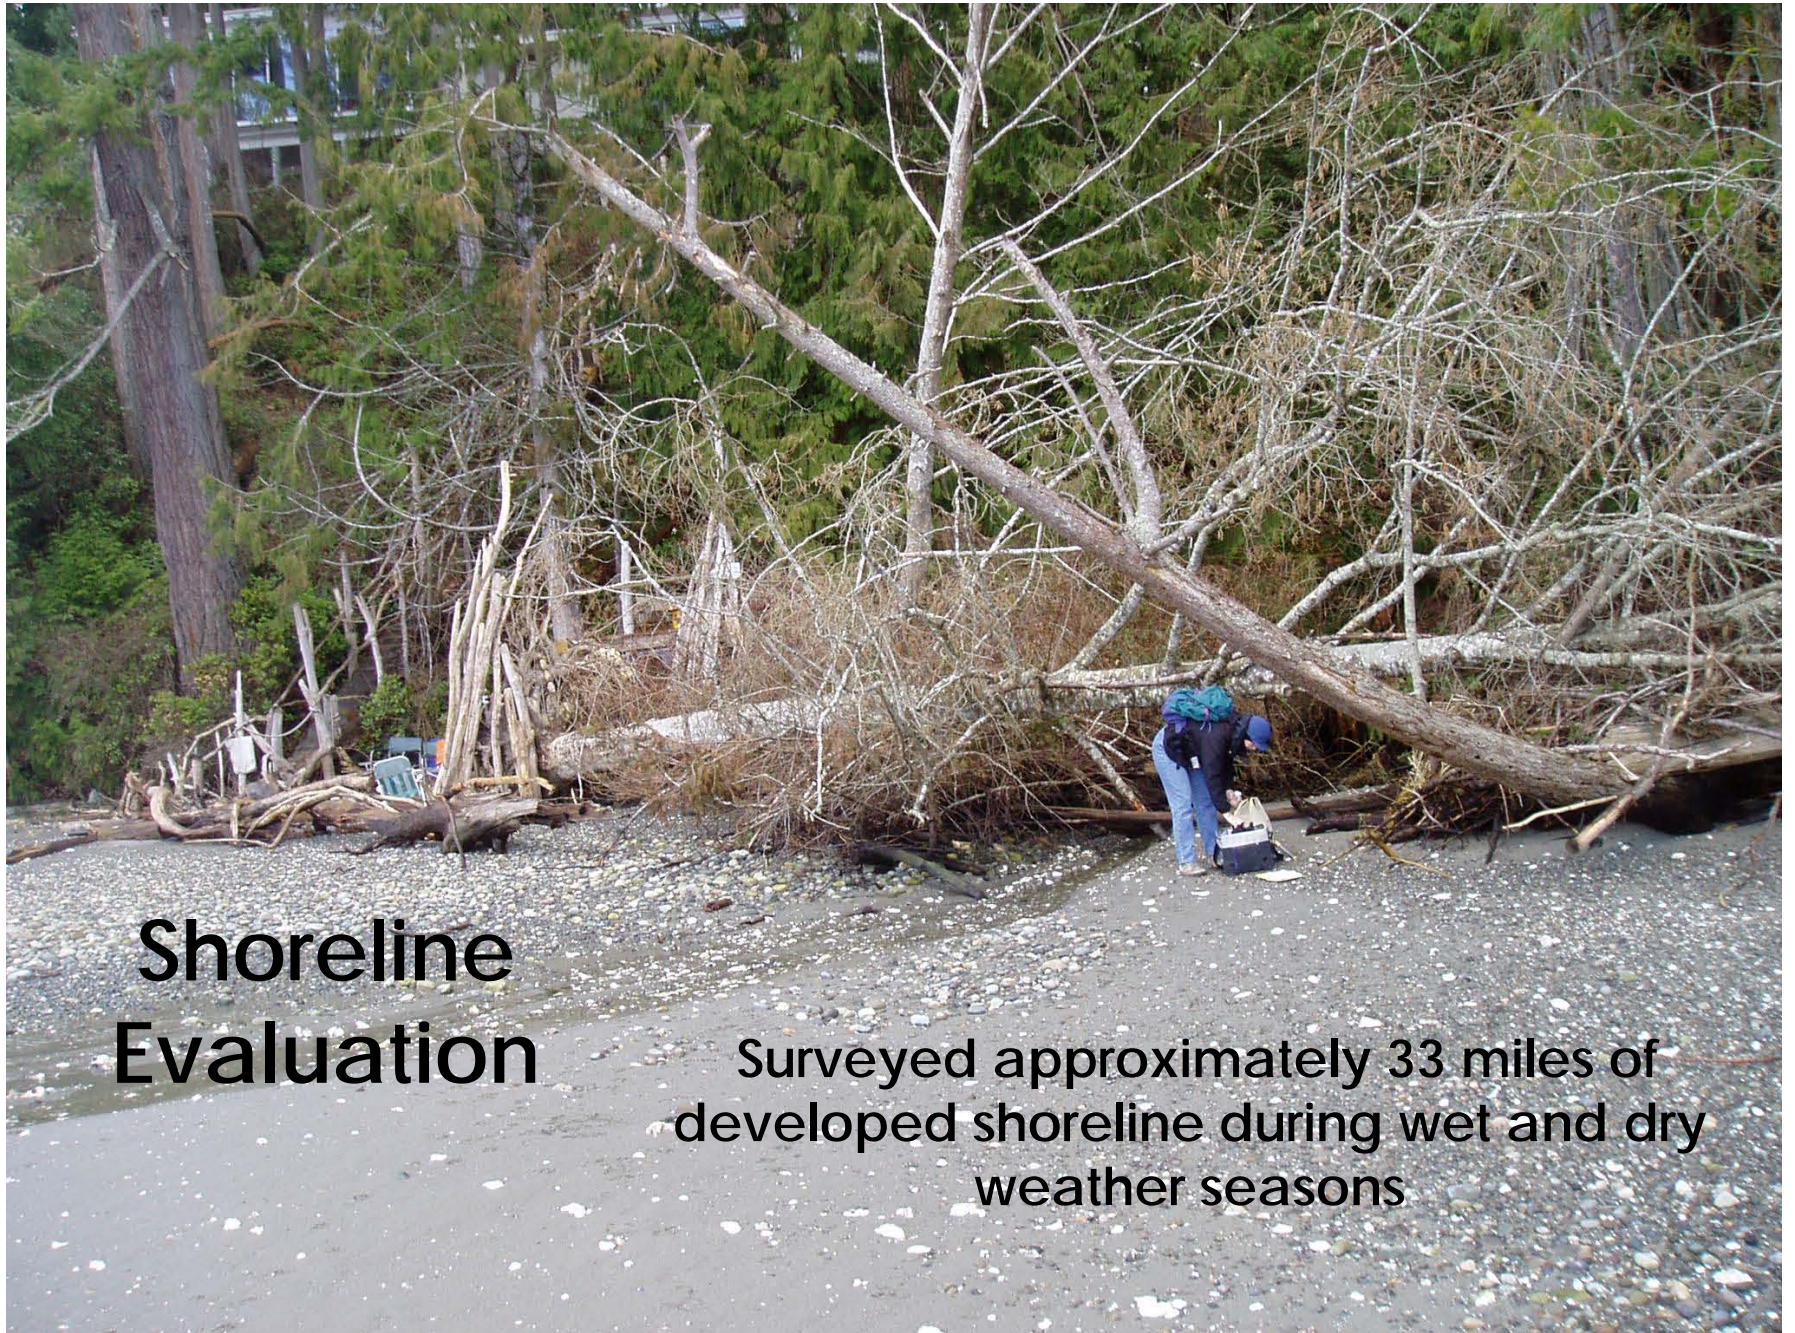
Shoreline Evaluation

Surveyed approximately 33 miles of
developed shoreline during wet and dry
weather seasons

Fecal coliform

Flow

GPS

Photo

Description
